QUINNIPIAC RIVER BASIN  
WALLINGFORD, CONNECTICUT

# SIMPSON POND DAM CT 00630

## PHASE I INSPECTION REPORT NATIONAL DAM INSPECTION PROGRAM

Identification Number:	CT 00630
Name:	Simpson Pond Dam
Town:	Wallingford
County and State:	New Haven County, Connecticut
Stream:	Wharton Brook
Date of Inspection:	October 23, 1980

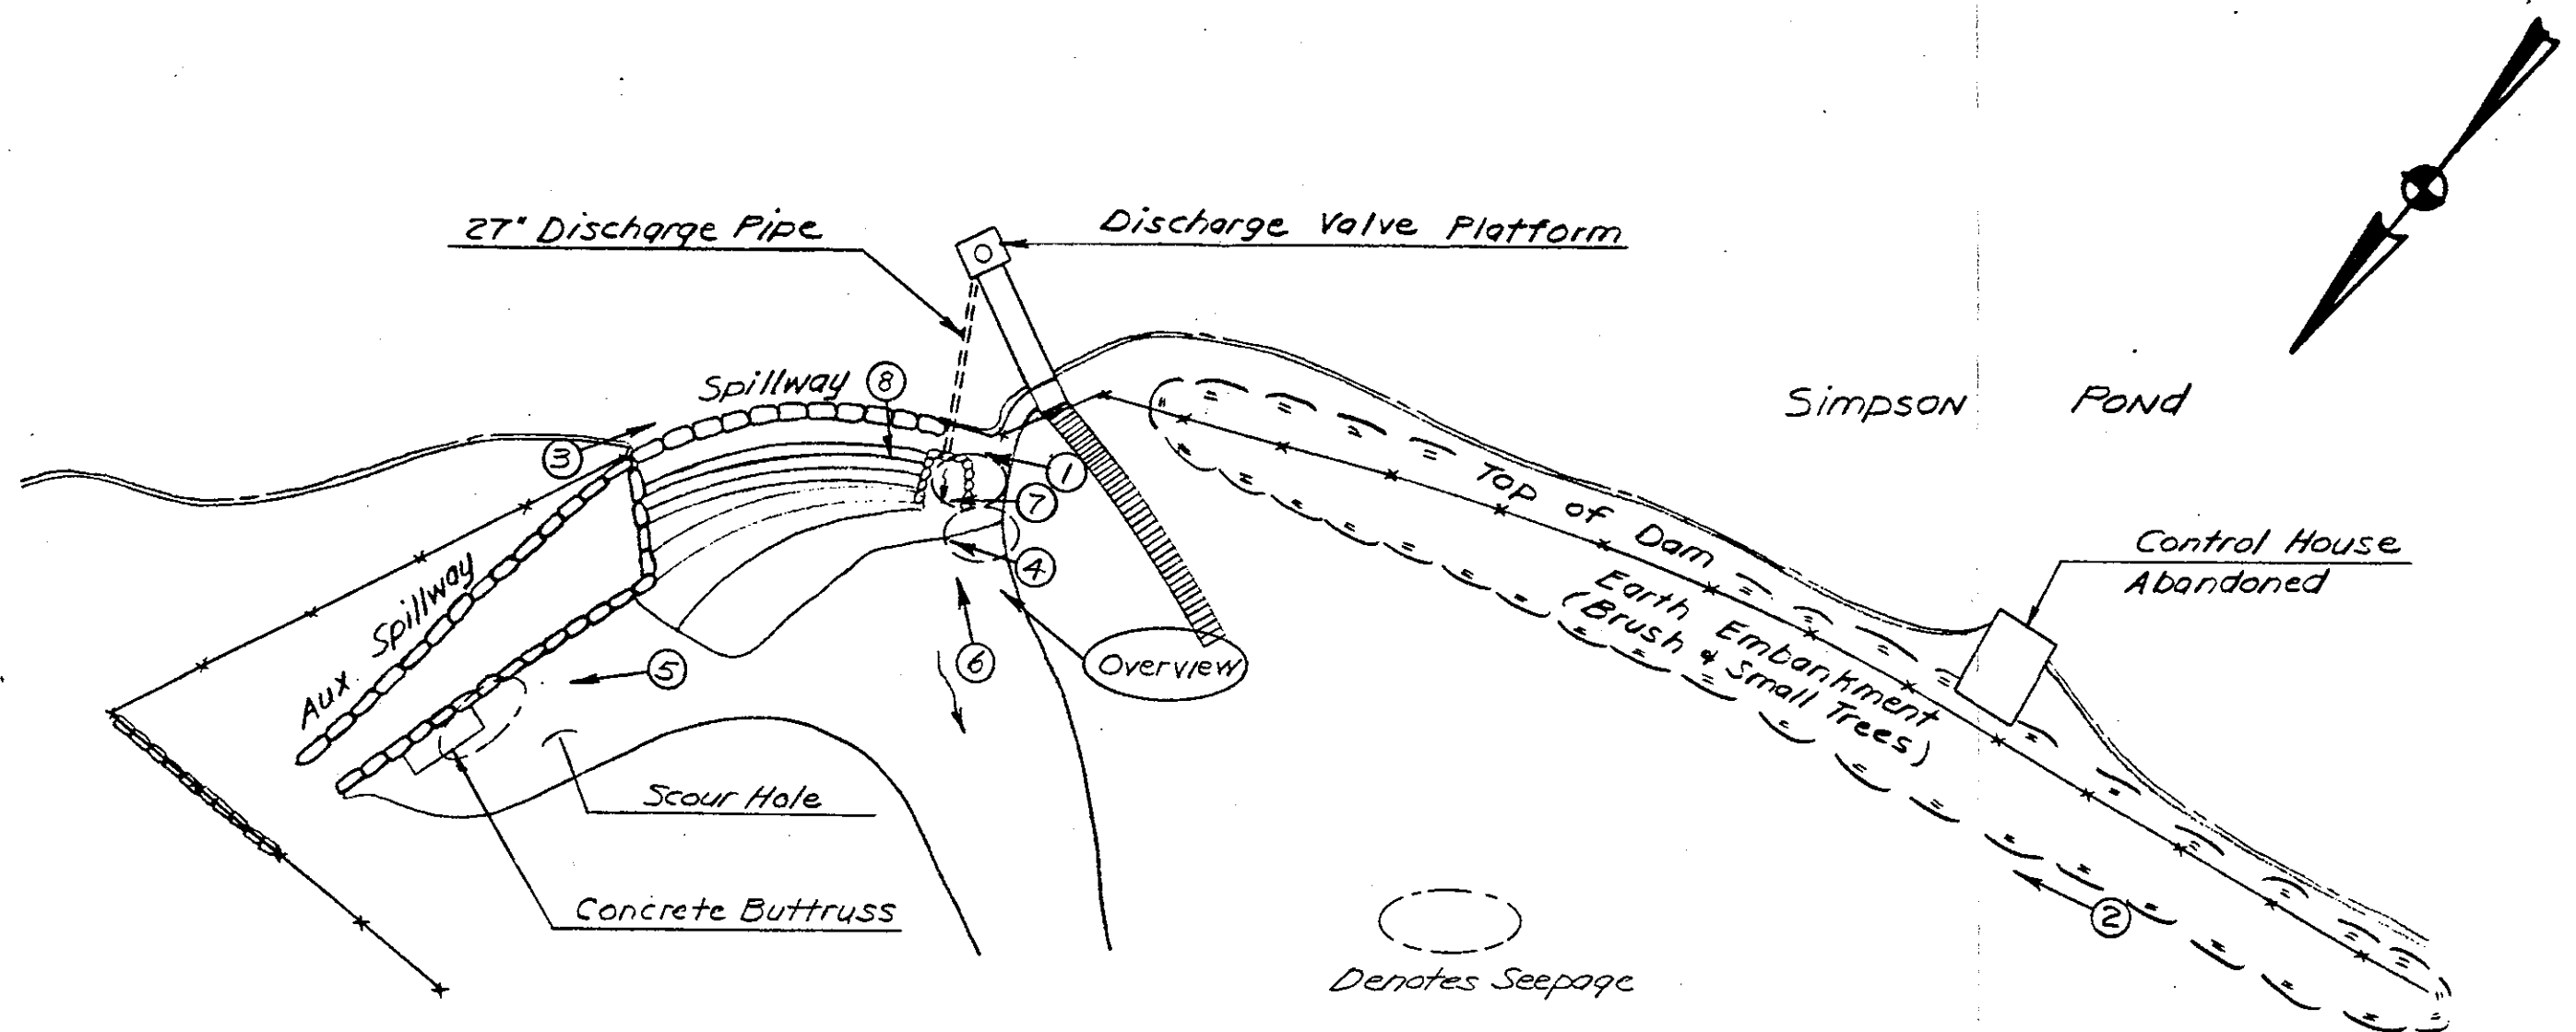
PLATE 3

There are several areas of seepage through and adjacent to the masonry face of the dam (Photos 5 and 7 - See Photo Location Plan Plate 3 for location). On the north side of the spillway, below the auxiliary spillway is a concrete buttress that has seepage beneath it. It is undermined and spalled. The stone masonry face below the south side of the spillway and near the toe has seepage also. The amount of seepage at all locations could not be measured. The seepage was clear and showed no signs of particle movement.
